Manhole Inspection Summary

Manhole # S17GG1003MH

Insp Date: **1/8/07 2:13 PM**

Location Address: **4007 SPRUCE DR**

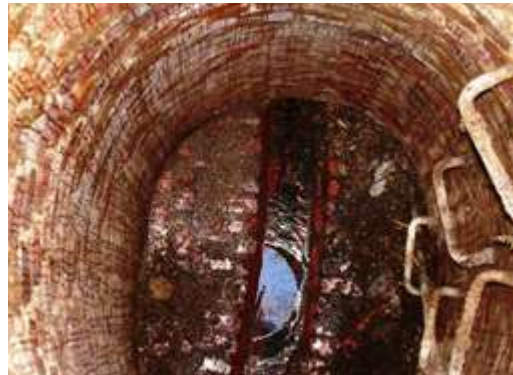
Top View

Corroded steps. Evidence of surcharge - Bench debris. Channel debris.

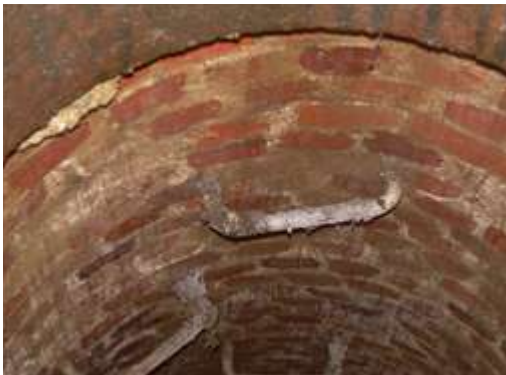
Defect

Adjustment infiltration - other side.

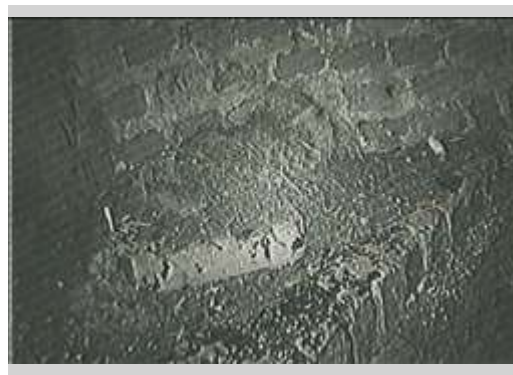
Defect

Barrel root intrusion and debris.

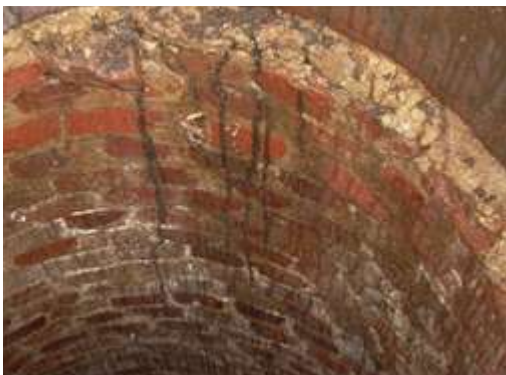
Defect

Adjustment deterioration and infiltration.

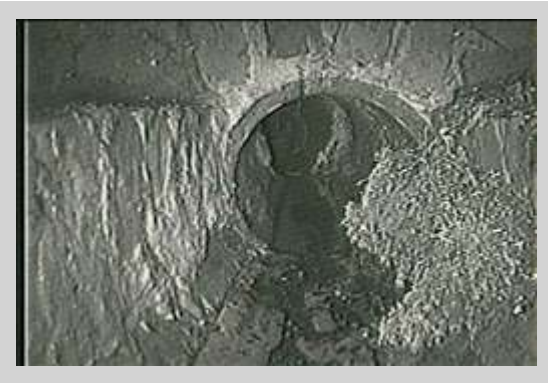
8 in. Circular Gravity Sewer Pipe Out @ 12 O'Clock

Channel root intrusion.

Infiltration: **Evidence** Pipe Seal Cond: **Cracked**

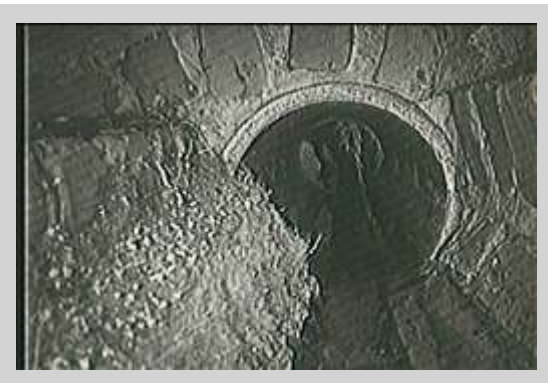
8 in. Circular Gravity Sewer Pipe In @ 7 O'Clock

Channel root intrusion.
